PERFORMANCE BULLETIN

FOAM BALL TESTING THROUGH PBL® MULTIPLE ACTIVATION BYPASS SYSTEM

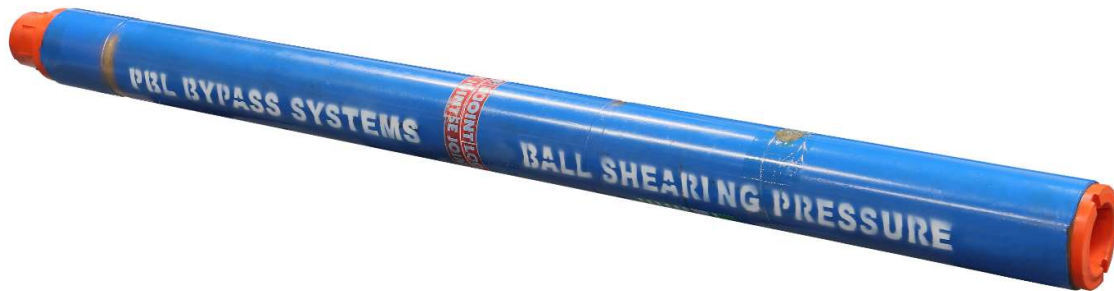
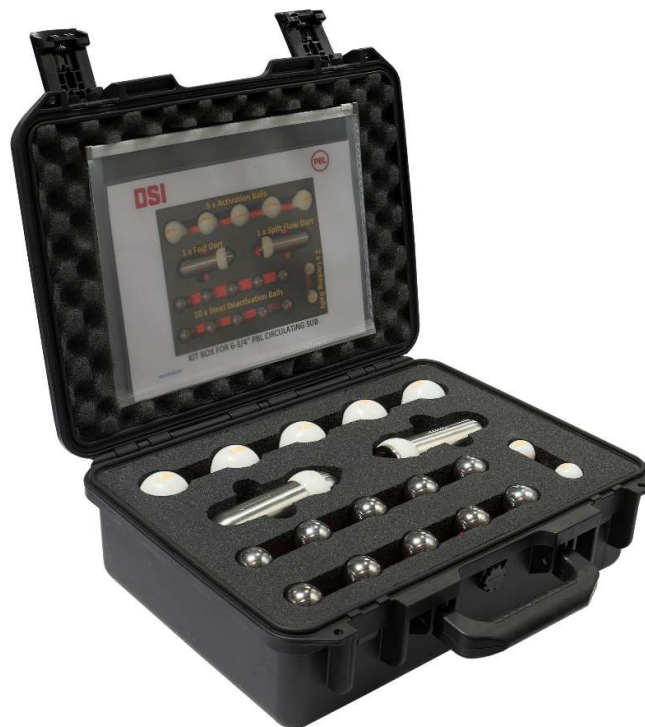
Pic 1. PBL Circulating Sub and Tool Box

TFS Services AS supplied the following DSI Dual Ported PBL Multi-Activation Circulating Subs:

6-3/4" PBL with Serial # WES 675 SBP 577

Port size: 2 no. 1.235" diameter (Total TFA= 2.396 sq. inches)

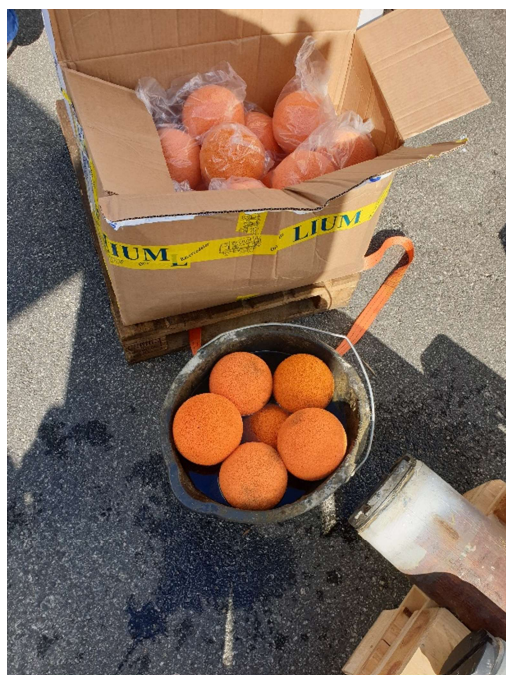
Pic 3. 5" Foam balls used for testing

All 5" OD Foam balls were provided by a third-party service company.

Pumps were stopped and the pup joint lower connection was broken and 2 x 5" OD foam balls were pushed inside the pin end of the pup. The pup joint was made up again. The system 'pop-off' valve was set to 180 bar to ensure the PBL sub did not de-activate if the foam balls plugged the side ports (The PBL sub de-activation shear pressure was 221 bar).

We observed a variance in the increased SPP which was recorded as the foam balls passed through the PBL sub ports. This may have been due to the fact that the foam balls were supplied in two separate batches, with the densities of each ball appearing to vary. Foam balls are known to be supplied in hard, medium, and soft compounds.

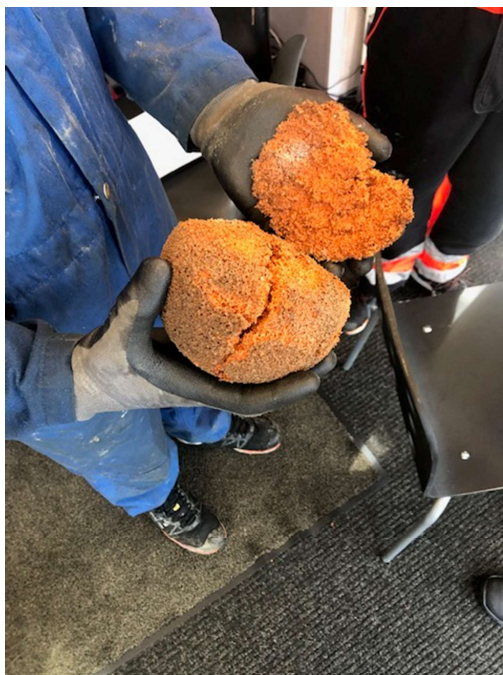
Pic 4. 5" foam ball after passing through PBL ports

The two foam balls successfully passed directly through the ports of the PBL sub without incident. The SPP briefly increased to 48 bar as the foam balls went through the ports. Flow rate was then increased to 1000 lpm (13 bar) for approx. 1 – 2 minutes to ensure any remaining debris from the foam balls was cleared.

The flow rate was reduced to 700 lpm with a SPP of 6.5 bar, which was the same pressure as before the foam balls were pumped through. The foam balls were

found in pieces in the settling tank confirming they had successfully passed through the ports of the PBL sub.

The flow rate was reduced to 700 lpm with a SPP of 8 bar, which was the same as before the foam balls were pumped through. The foam balls were found in pieces in the settling tank confirming they had successfully passed through the ports of the PBL sub.
